1 ***High-resolution spatiotemporal analysis of hydrologic connectivity in the historical floodplain***
2 ***of straightened lowland agricultural streams***

24 **ABSTRACT**

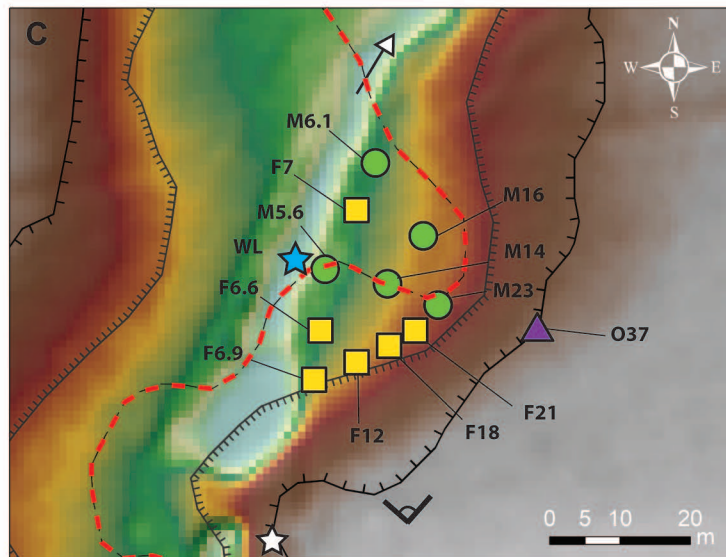
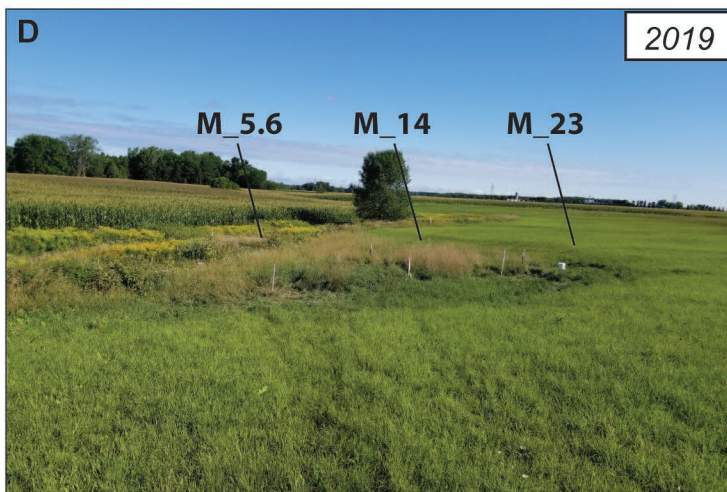
116 **Figure 1:**

105 The Petit-Pot-au-Beurre stream is a small second-order stream having a drainage area of 12.8 km² (Figure
106 1). The watershed is mostly covered (approx. 90%) by crop fields (corn, soybean, and fodder plants). Our
107 study site (stream elevation approximately 15 m a.s.l.) encompasses one abandoned meander, the
108 surrounding historical floodplain, and the adjacent hillslope (Figure 1). The amplitude of the former
109 meanders in the 1-km studied reach varies between 10 and 52 m. Bankfull width and depth are
110 approximately 3 m and 1.5 m, respectively. The average annual discharge at the on-site gauging station is
111 0.2 m³/s with an annual peak discharge slightly greater than 3 m³/s. The stream can dry out during the
112 summer. The channel was straightened between 1964 and 1966, and backfill material was placed upon
113 the former channel and the floodplain, erasing most topographic features. A shallow half-circular

114 depression is the only remnant of surface topography from the pre-straightening floodplain. No
115 subsurface drainage is present in the study area.

Piezometers in the abandoned meander		Channel logger:	
Piezometers in the floodplain outside the abandoned meander		Barometric logger:	
Piezometers outside the floodplain:		View angle (D)

DEM (m. a.s.l.)		
	High: 18.6	Actual stream
	Mid: 17.0	Top of hillslope (pre-disturbance, 1965)
	Low: 14.5	Base of hillslope (pre-disturbance, 1965)
		Abandoned channel
		Flow direction

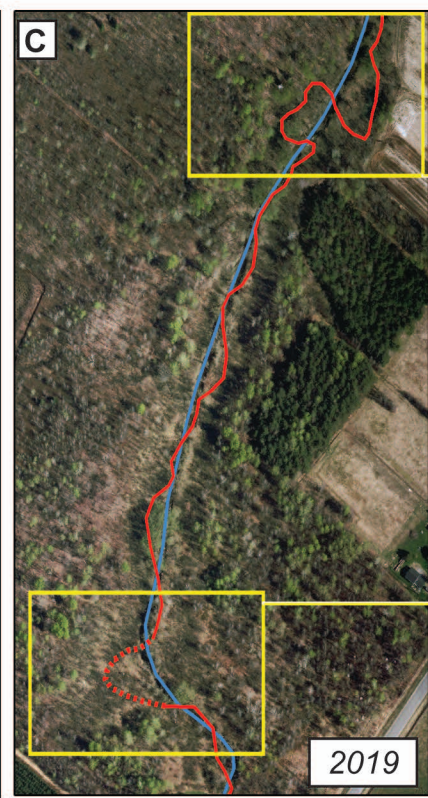
133 **Figure 2.**

117 The Ruisseau Martin (RM) is a midsize, second-order stream having a drainage area (26 km²) that is 90%
118 covered by agricultural fields of mainly maize and corn (Figure 2). The average historical meander
119 amplitude and floodplain width average are 60 and 80 m, respectively. The modern channel bankfull width
120 and depth are 5 m and 2 m, respectively. The average annual RM discharge is 1.5 m³/s at the on-site
121 gauging station. We monitored two sites along a 500 m reach of RM. The RM-UP site encompasses a 41-
122 m wide abandoned meander having a floodplain on either side of the channel (note that all references to
123 left and right in this paper are when looking downstream). The RM-DS covers a 22-m wide abandoned
124 meander and the surrounding left floodplain (Figure 2). The channel was straightened between 1965 and
125 1966, but no backfilling was added to the floodplain. Thus, the straightened channel flows through an

126 undisturbed floodplain that is bounded by a 3-m high hillslope on both sides. Small gullies have formed in
127 the left-side hillslope, indicating potential surface runoff during precipitation events. The studied sites
128 were cultivated until the 1980s. Since then, no cultivation has taken place, and natural (unassisted)
129 colonization by vegetation has occurred. This site allows observation of a fully mature forest, including
130 shrub and forested swamps and herbaceous marshes. This site allowed observation of the evolution of a
131 straightened channel and floodplain following completely passive vegetation restoration (40 years). No
132 subsurface drainage is present in the study area.

- Channel logger: ★
- Barometric logger: ☆
- Piezometers in the abandoned meander: ●
- Piezometers in the floodplain outside the abandoned meander: ◻
- Piezometers outside the floodplain: ▲

- Actual stream: — (solid blue line)
- Abandoned channel (pre-1950/post-1950): - - - (dotted red line)
- Top of hillslope: —|— (solid line with vertical tick)
- Base of hillslope: - - - (dashed line)
- Flow direction: —▶ (solid line with arrowhead)

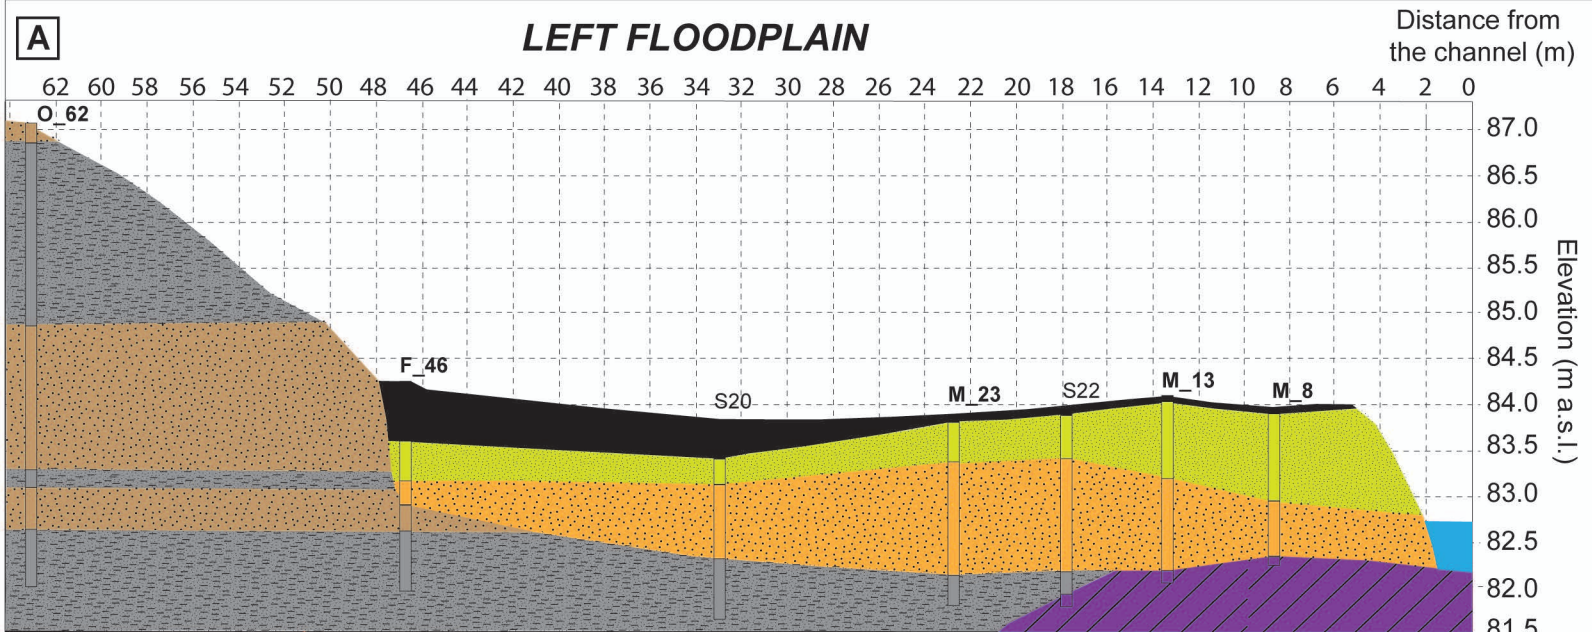
226 **Figure 4.**

214 The RM floodplain shows an alluvial unit ranging from 0.70 to 1.95 m in thickness (Figure 4 (RM-UP), see
215 Supplementary material: Figure A for RM-DS). Despite much heterogeneity in the subunit assemblages,
216 the logs from the floodplain generally show fine sand, grading into medium to coarse sand with woody
217 deposits. Some morphological features show active erosional or depositional surfaces, which suggest
218 recent surficial floods. The regional unit forming the left hillslope of the RM stream reveal alternating
219 medium sand and clayey silt deposits of varying thickness, also described as shallow marine surficial
220 deposit from the St. Lawrence Lowlands. The floodplain is embedded in the same regional unit. At the
221 RM-UP site (Figure 4), a very hard clayey matrix is found beneath the regional unit in the right hillslope.
222 The alluvial material of the right end portion of the left floodplain as well as the right floodplain is

223 embedded in the same material, described as glacial till (Ministère des Ressources naturelles et de la
224 Faune du Québec, 2012). The average hydraulic conductivity values for the medium sand and clayey silt
225 regional units and for the alluvial units are 2.61×10^{-5} , 2.46×10^{-7} and 1.96×10^{-5} m/s, respectively.

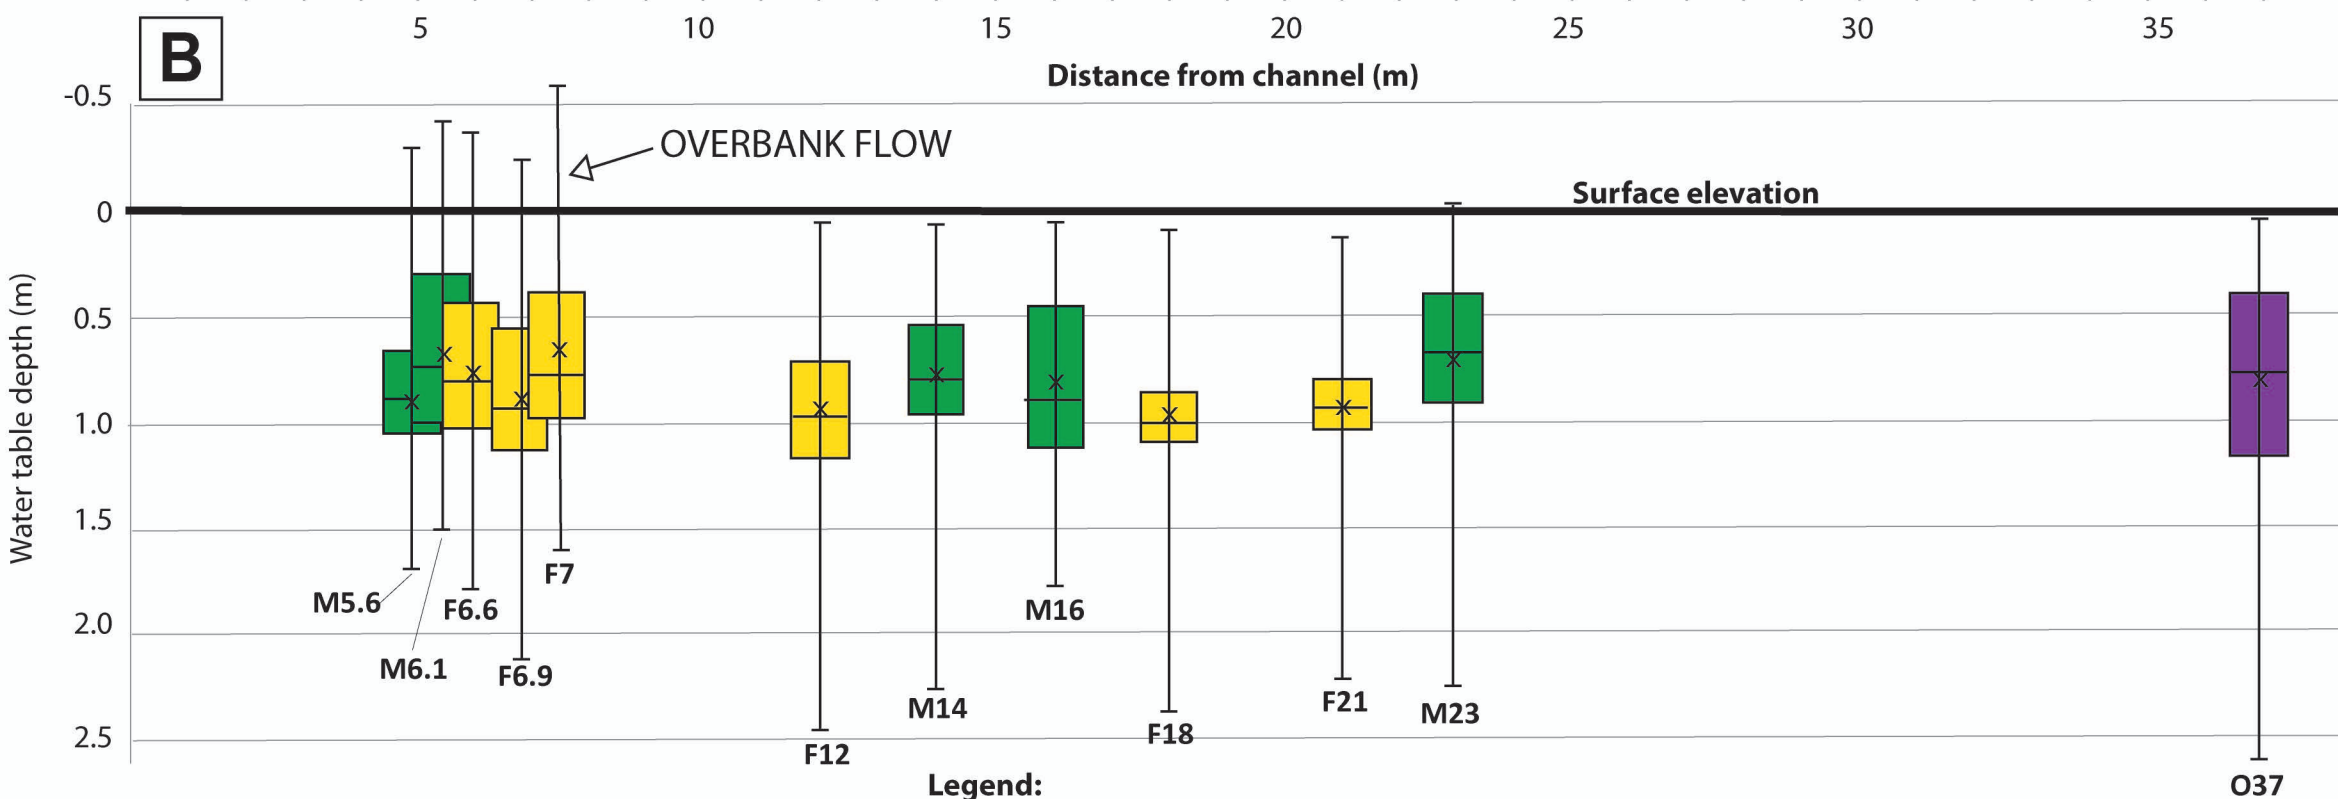
262 **Figure 6:**

250 Observations of seasonal water level patterns suggest that the hydraulic gradient in the PB and RM
251 floodplains remains predominantly oriented toward the channel during the entire flood periods when
252 water levels in the channel remain below bank level (Figure 6A, see Supplementary material Figure B, C).
253 On some occasions at PB, at the onset of a hydrological event, a slightly inverted hydraulic gradient
254 develops between the groundwater level in the piezometers close to the channel and those located near
255 the hillslope (Figure 7). Overbank flood events only occur on few occasions (in early spring at PB, in spring
256 and fall at RM). At PB, overbank floods are limited to narrow strips near the stream, as illustrated by
257 maximum values exceeding surface elevation in Figure 6B. At RM, overbank flood events systematically
258 cover the entire historic floodplain (Supplementary material: Figure B and C). During the entire flood

259 period at the PB and RM sites, water levels in the hillslope remain constant and exceed the heads in the
260 nearest floodplain piezometer by at least 0.5 m (Figure 6A, Supplementary material: Figure B and C). The
261 only exception is the RM-UP right hillslope where no water was ever detected in the piezometer.

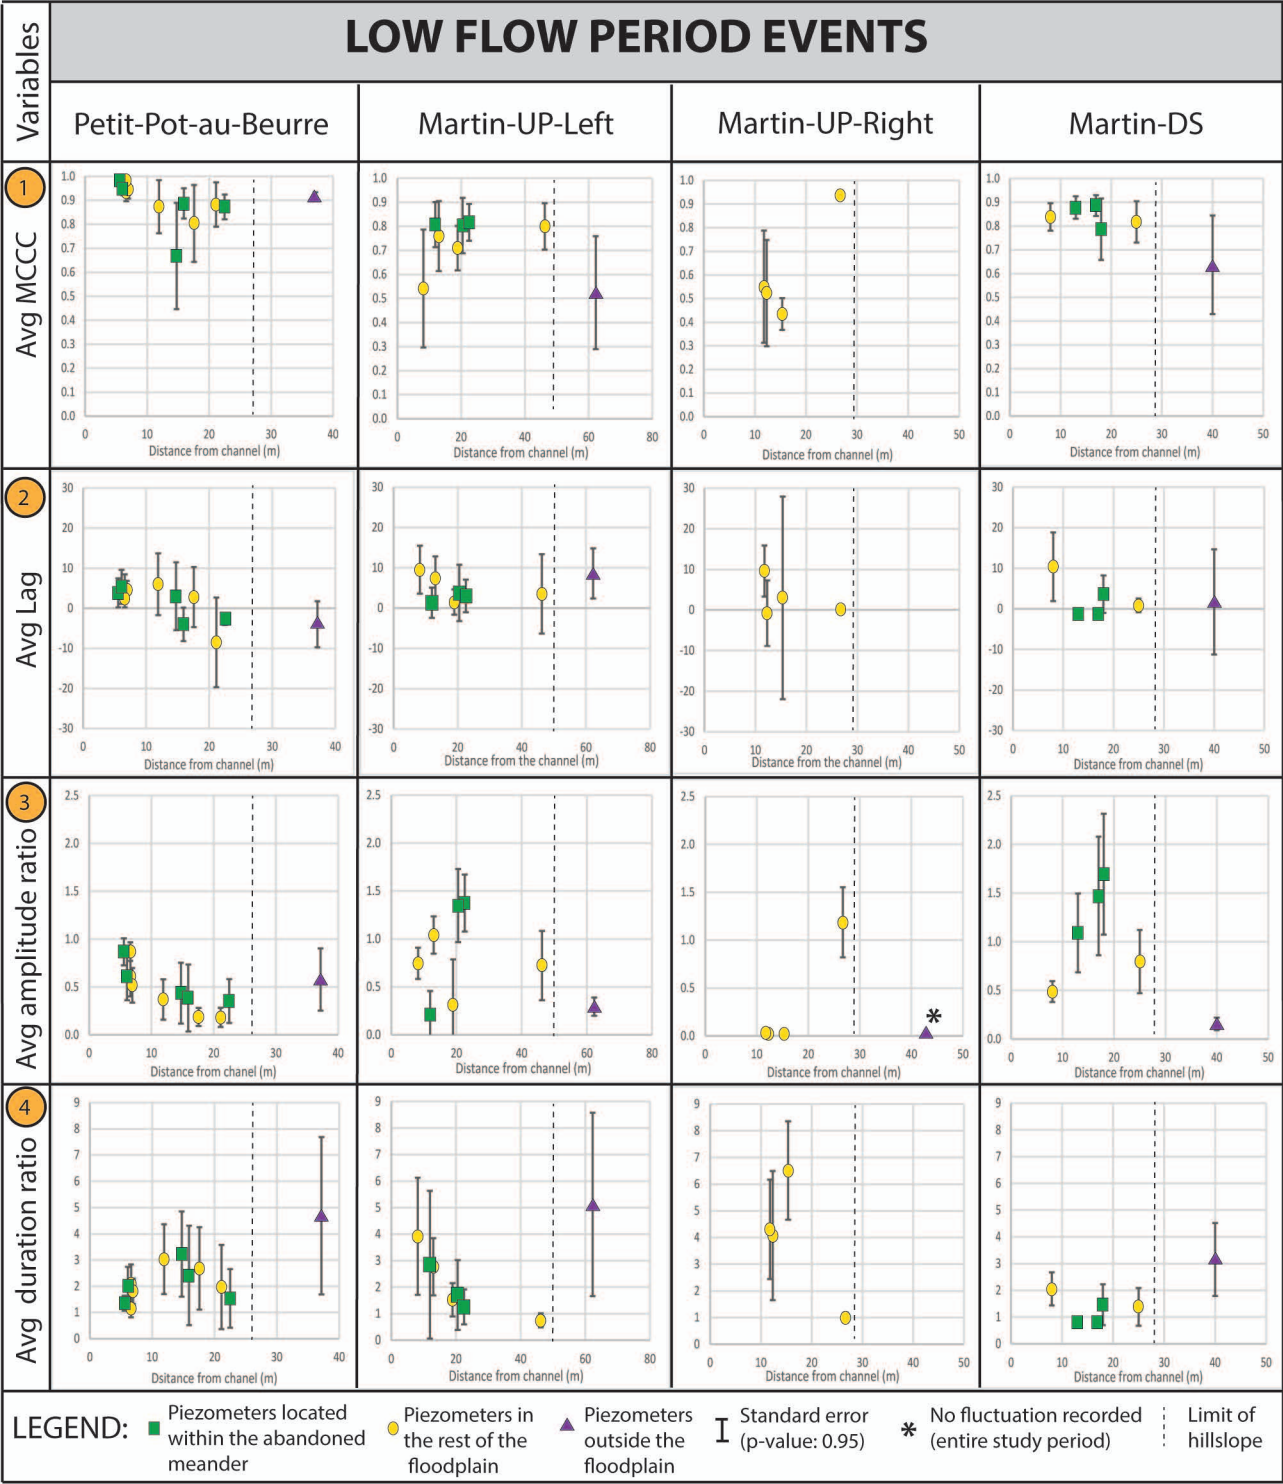
293 **Figure 8.**

278 For hydrological events occurring during the low-flow period, lower values of MCCC are generally
279 observed in the historic floodplain than during the flood periods (Figure 5 and 8, row 1). The most obvious
280 difference between the flood period and the low flow period is observed in the piezometers located near
281 the actual channel at the RM-UP site with the highest average MCCC values measured closer to the
282 hillslope, unlike the PB site (Figure 8, row 1). The same difference between sites applies to the amplitude
283 of head fluctuations with the amplitude ratio at PB generally much lower near the lateral limit of the
284 floodplain during the low-flow period (Figure 8, row 3), indicating fluctuations with relatively small
285 amplitude compared to those close to the channel. Unlike PB, the average peak amplitude ratio at RM is
286 higher close to the lateral limit of the floodplain than close to the stream (Figure 8, row 3).

287 At the RM sites, piezometers located in the abandoned meander exhibit the highest amplitude among all
288 piezometers (green squares in Figure 8, row 3). Results at RM also suggest that the relative duration of
289 hydrological events is shorter in piezometers located in the abandoned meander (Figure 8, row 4). Among
290 all the sites, the average time lags oscillate between -8.5 and 10.8 h (Figure 8, row 2), with less contrast
291 for piezometers located within the abandoned meander than piezometers located outside the abandoned
292 meander compared with the flood period.

367 that lag-time values can help differentiate signal propagation of regional groundwater (negative lag) from
368 surface water-groundwater connectivity at the channel-bank interface (positive lag) (Figures 5 and 8).

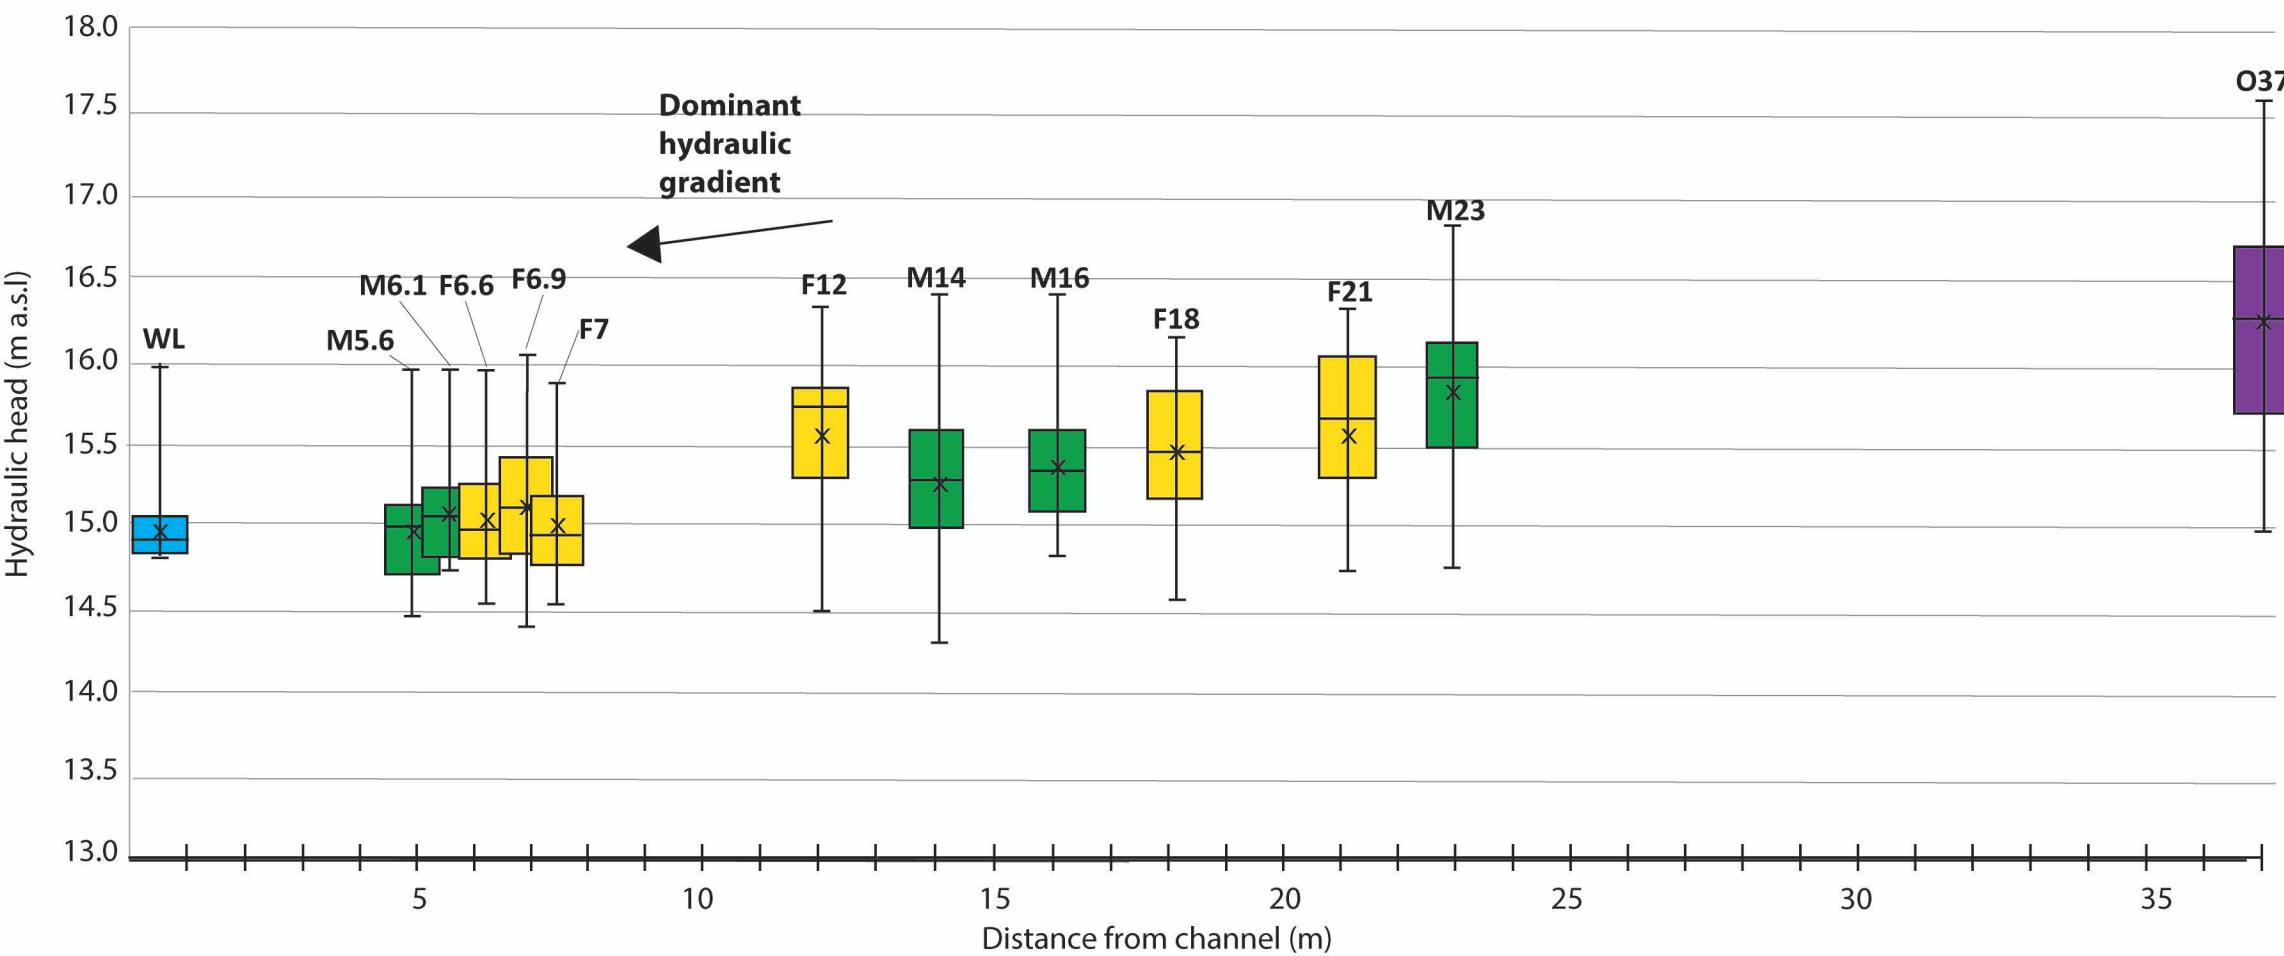
306 **Figure 9.**

294 The hydraulic gradient at all sites during the low-flow period is generally stream oriented (Figure 9, see
295 Supplementary material D and E). At PB, short-duration gradient inversion occurs between the stream

296 and the piezometers close to the channel due to a slight delay between the head response in the
297 piezometers near the channel and the fluctuation in the channel. This contrasts with the flood period
298 where a hydraulic gradient inversion only occurred during overbank channel events. By the end of the
299 summer at PB, groundwater levels eventually decrease below the piezometer, resulting in a net decrease
300 of hydraulic gradients. At the RM sites, the decrease of the head on the hillslope never exceeded 1 m
301 (Supplementary material: Figure E and F). Unlike PB, a strong hydraulic gradient from the hillslope to the
302 floodplain thus remained throughout the study period. No overbank event occurred at both sites during
303 the entire low-flow period (Figure 9B). However, at the RM sites, water table elevations occasionally
304 reached the surface elevation of the floodplain, specifically at the location of the abandoned meander

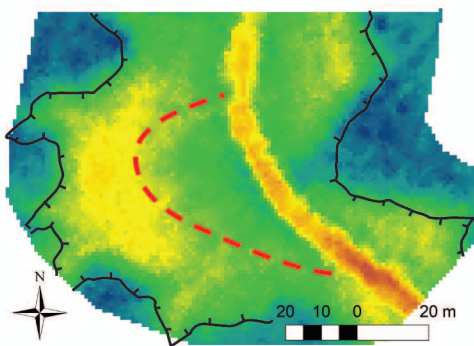
333 **Figure 10.**

324 Results from this study converge to support the idea that straightened lowland streams can still be
325 hydrologically connected to their historic floodplain. For example, the generally high MCCC values and
326 low time lag values indicate strong synchronicity between fluctuations in straightened lowland rivers and
327 those in their historic floodplain. In addition, our findings provide evidence that abandoned meanders
328 have a higher level of hydrological connectivity within the floodplains. This is particularly evident when
329 events are analysed independently of each other. For example, the hydrograph for the event of August 8,
330 2019, at RM-UP (Figure 10) reveals that most fluctuations recorded in the floodplain were concentrated
331 around the abandoned meander apex and near the hillslope (left and right), and that these fluctuations
332 occurred slightly before those in the piezometers near the channel.

(1) 2019-08-08, 7:00 AM, Pre-event

(2) 2019-08-08, 12:00 PM, Peak

(3) 2019-08-09, 12:00 PM, Post-event

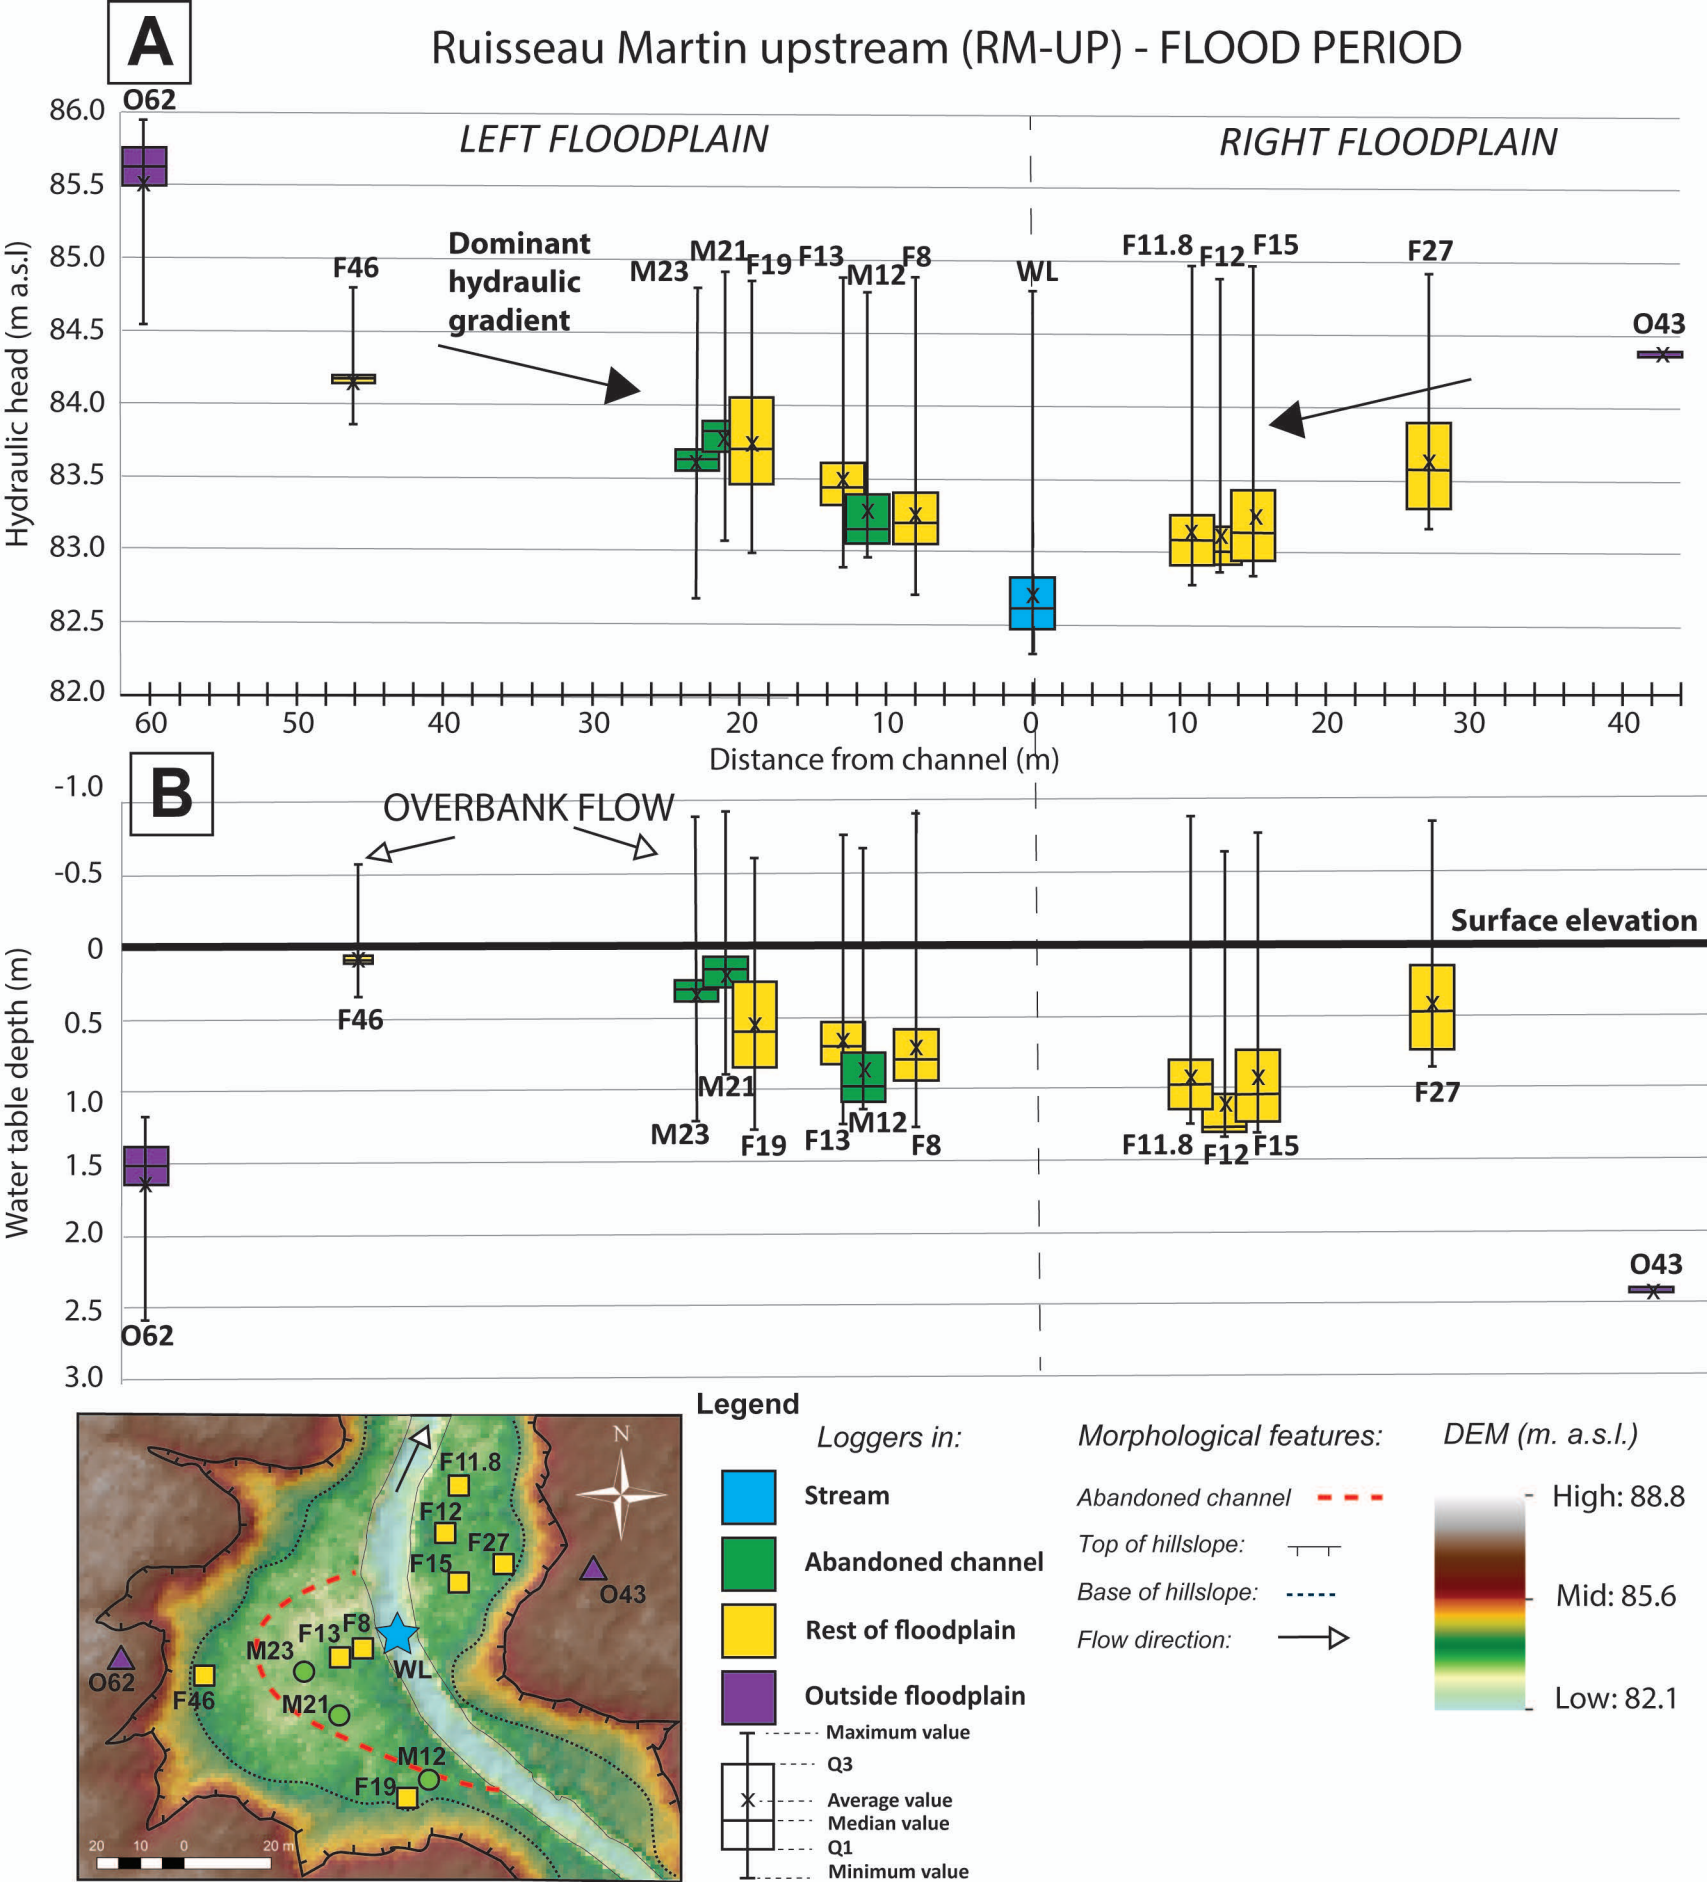
Figure B. Box plot graphs showing A) hydraulic head elevation and B) water depth of piezometers installed at the Ruisseau Martin upstream sites for the flood period (mid-March to mid-May and early October to late December). Negative water depth values indicate water level above the surface.

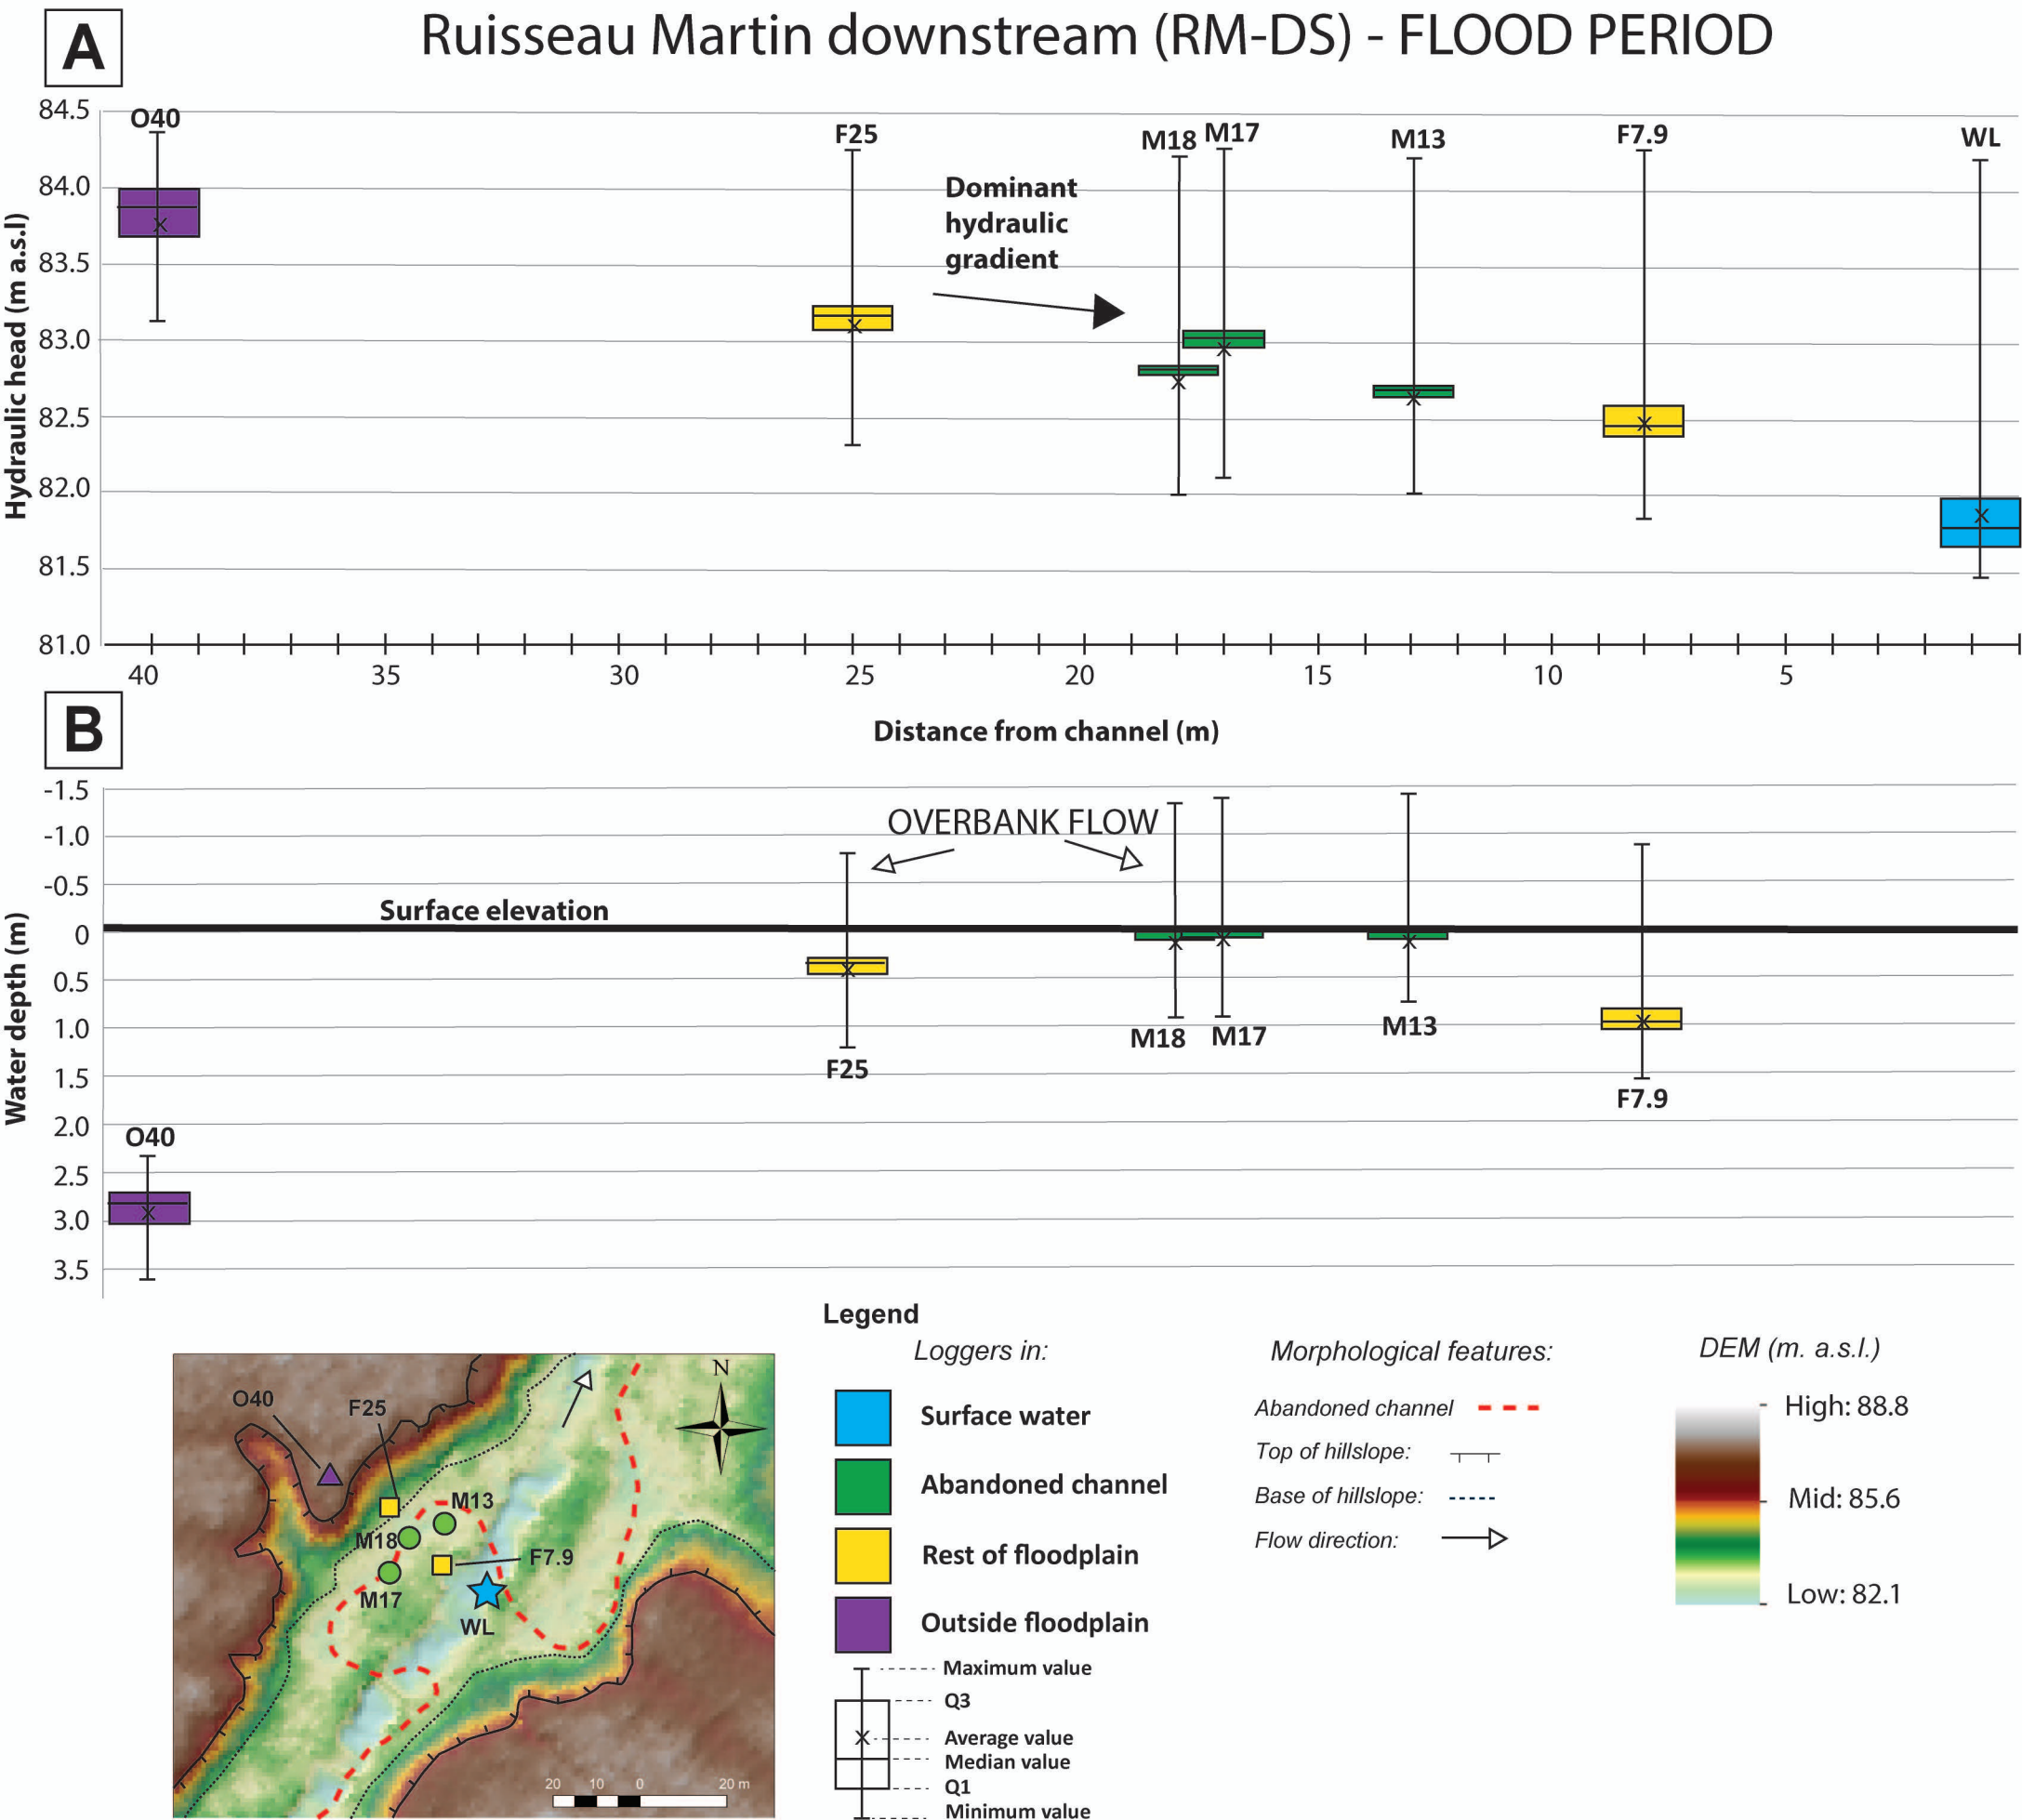
Ruisseau Martin downstream (RM-DS) - FLOOD PERIOD

Figure C. Box plot graphs showing A) hydraulic head elevation and B) water depth of piezometers installed at the Ruisseau Martin downstream site for the flood period (mid-March to mid-May and early October to late December). Negative water depth values indicate water level above the surface.
